# GA ILAHFFT - ALL SECURE?

Dear fellow aviators, the following account of a compound rigging and daily inspection error might be of interest, especially to those flying Standard Cirrus gliders, although I suppose similar battery installations can be found in many other types.

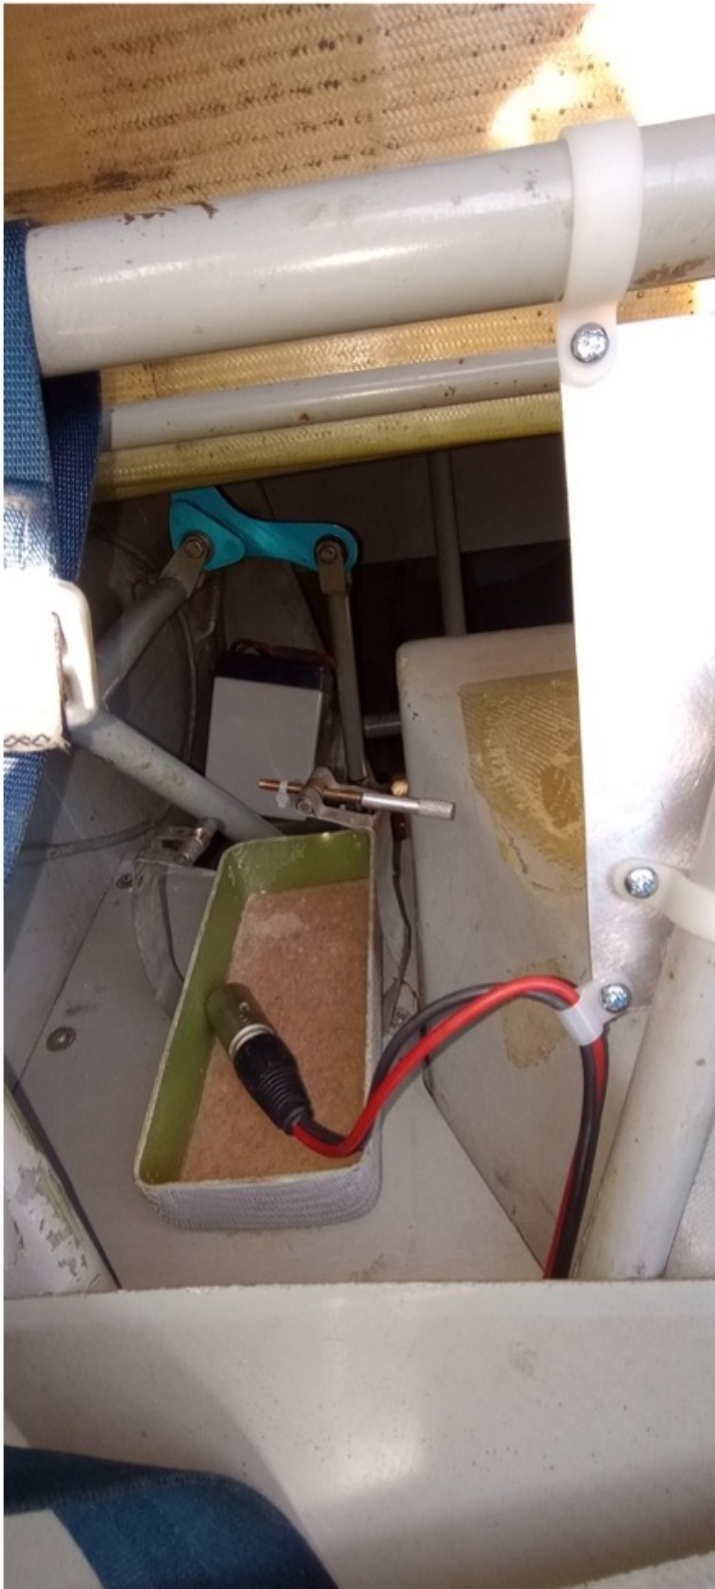
When we de-rigged at the end of the day, we found No1 battery had dislodged from its tray and slid backwards into the area to the right of the U/C housing where the aileron-rod junction branches off into the starboard wing. When we had installed it to check the variometer we hadn't secured its safety latch and subsequently completely forgot about it. Although it was possible to move the control rod, the battery was lying on top and was being bounced around by any control column movement. Additionally, we noticed that the U/C rod extended back into this space, and the battery would have prohibited its movement if it happened to be settled in the rod's way.

Although it appeared that the battery did not completely obstruct the movement of the aileron control rod, it might be possible that such a situation could occur, either if it settled in a position which did not happen on the day, or if a slightly differently shaped – perhaps smaller – battery was installed.

I should perhaps add that my syndicate partner and I had never included an additional check of the battery position and latches in our DIs. They were simply always put in their slots, secured and the seat's back-rest put back in place and secured with its screw. Needless to mention that the installation of a battery is not mentioned in the aircraft operating manual in a glider of this vintage. Make sure to check that batteries are installed and secured correctly as part of DI, and always secure batteries, even when 'only' using them on the ground to check something.
