# DUAS18

**Report Title** Battery installation failure

## Initial Report

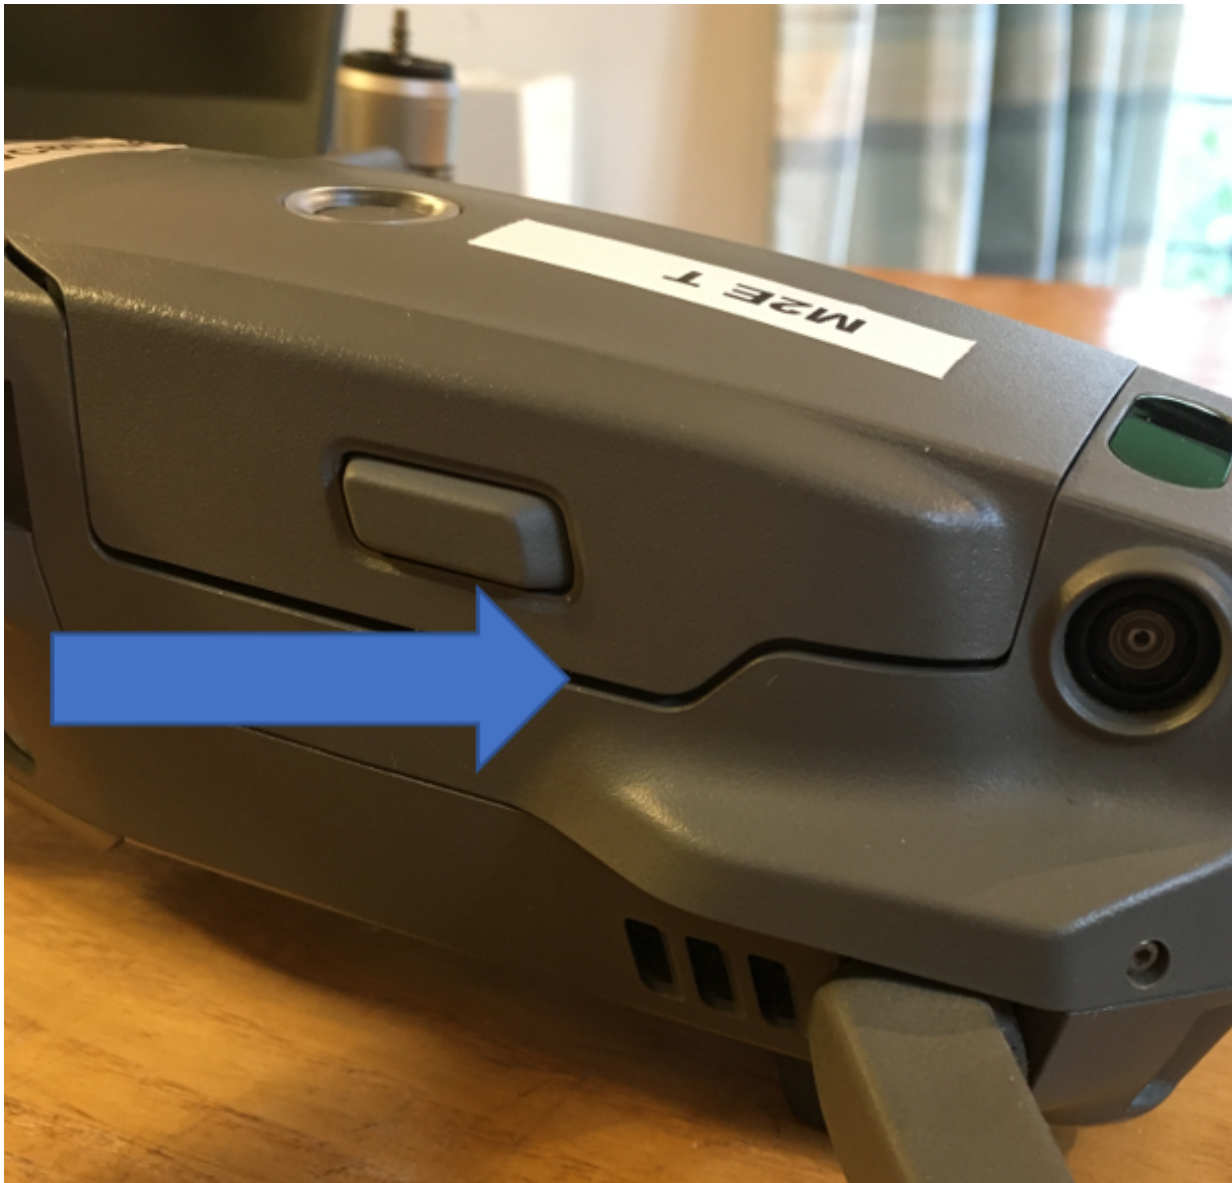
The flight crew were wearing gloves to install batteries into a Mavic 2 Enterprise Advanced. The battery powered-on the UA but when it came to take off, an error was displayed stating that the battery was not inserted correctly. The flight was cancelled. Upon visual inspection, the battery looked as if it was installed correctly, but when it was firmly depressed, 2 audible clicks were heard, and the battery was then secure. It was about 1°C and the flight crew were wearing gloves that would have meant loss of dexterity.

**Figure 1 – Battery not clicked into place (note gap)**

1. Install battery onto the UA. Ensure a click is heard as the battery clips into place. Note that more than a single click may be heard.
2. Try to remove the battery without pressing the battery release tags.
3. Repeat the above procedure or cross check with another remote pilot if you are unsure.
4. Check for warnings on the controller before launch. If a warning is seen, cancel the flight and rectify.

- For this model of RPAS, hearing the double click and feeling for the potential gap (with gloves removed), is essential!
- If you are operating in low temperatures, always be aware of the operating temperature range. In the case of a Mavic 2 it is  $-10^{\circ}$  to  $+40^{\circ}$  C

- The Manufacturer or Operator might consider applying witness lines, which would make it easier to visually identify an incorrectly seated battery.
- It is worth noting that just because the Mavic 2 is thought of as being easy to deploy, it does not mean the pilot can ignore pre-flight checks. Easy to do in haste, but this may lead to repenting at leisure.

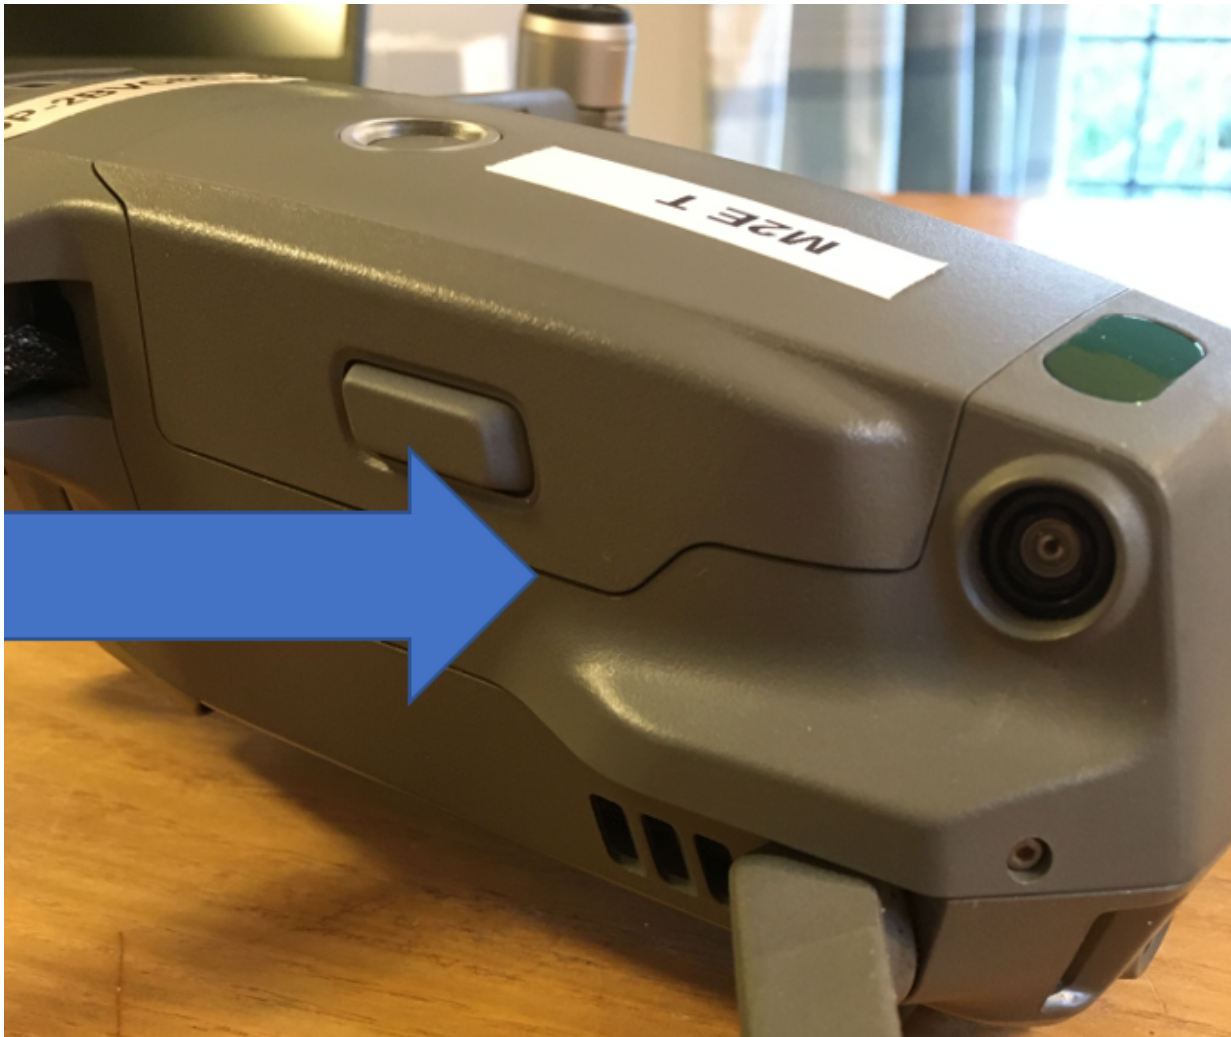
**Figure 2 – Battery securely clicked into place (gap reduced)**
