## Editorial

Welcome to the 50th edition of Maritime FEEDBACK which is being prepared at Lunar New Year – so *Kung Hei Fat Choi* to all our readers, reporters and sponsors, and we wish you a safe and happy Year of the Dog.

### Rescue boat lifting strops

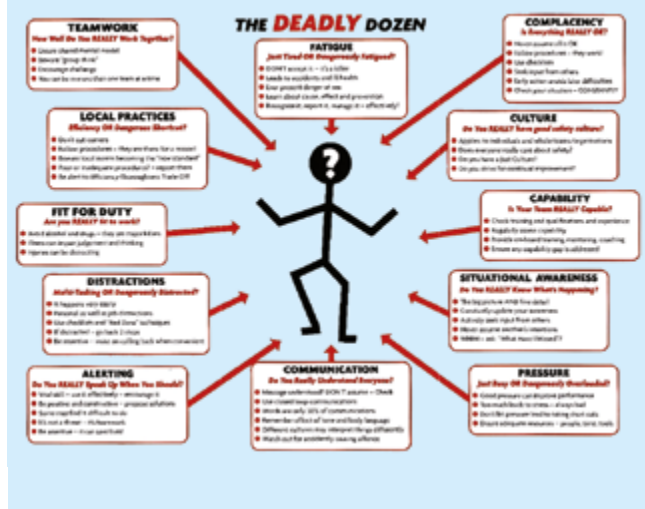
- The delay with the lift and the slippery towel. (**Local practices, Situational awareness, Complacency**)  
 With respect to the radio contact between the pilot and the bridge, **CHIRP** reinforces the fact that a cadet is not an appropriate person for supervising pilot transfer operations and that the regulations are quite specific as to the supervisory requirements. In addition, the Board commented that a request to alter course made from the pilot boat directly to the bridge may have been the better option.

The **CHIRP** Maritime Advisory Board commented that vessels should be well aware of the transfer arrangement requirements through SOLAS V 23, and the Pilot Boarding IMPA placard. Additionally, they should be well aware of their freeboard, and thus know exactly what to rig unless specifically requested otherwise. Nevertheless, the reporter highlights the necessity of clear instructions from the port. **CHIRP** would suggest that "SOLAS compliant" is perhaps not specific enough, and that a written or verbal phrase such as "Pilot ladder on the xx side of the vessel 2.5m above the water - please do not rig a combination ladder unless your freeboard is greater than nine metres" would be a clear request. This may well be of assistance where personnel receiving the request do not have English as their native language.
