MARITIME FEEDBACK

Issue 64
August 2021

An independent and confidential reporting system for the maritime industry

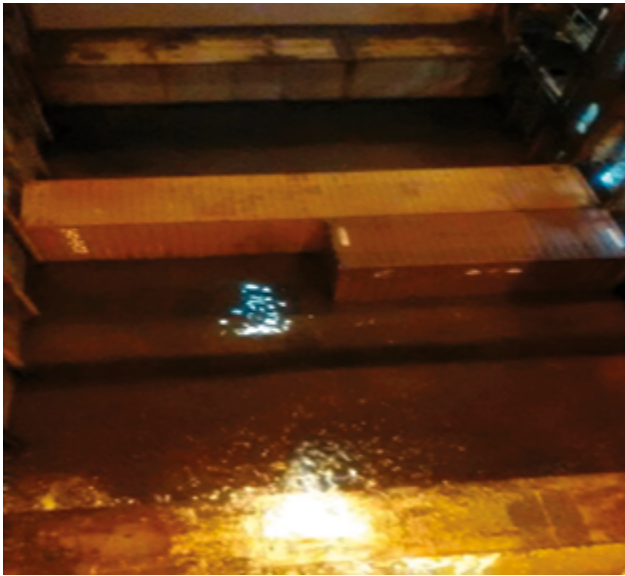
Shortly after starting, the hold bilge alarm sounded so the transfer of ballast water was stopped. No crew member was directed to investigate why the alarm had sounded; instead, the alarm was accepted, and the water transfer system reconfigured to pump out the hold. Ballast water transfer subsequently restarted but approximately 15 minutes later the No. 5 hold bilge's "Low insulation" alarm sounded. The ballast operation stopped once again while the ship's electrician was despatched to investigate. On arrival they found that the hold was flooded to a height of 1.70 m.

The next day the Chief Officer, Bosun and an AB entered Hold No. 5 to confirm that the water had been drained. When cargo operations resumed, 26 flood-damaged containers from Hold 5 had to be transferred ashore. During the inspection various hand tools (screwdrivers, hammer, and pieces of an old gasket) were discovered in the hold.

An investigation confirmed that the bilge and ballast system valves were in good condition, and the structural integrity of the cargo hold was intact. It concluded that water had entered the hold from a manhole that had not been properly secured following work within the double bottom tank. It was noted that the inadequate reaction by the crew when the bilge alarm was activated was a contributing factor to the incident.

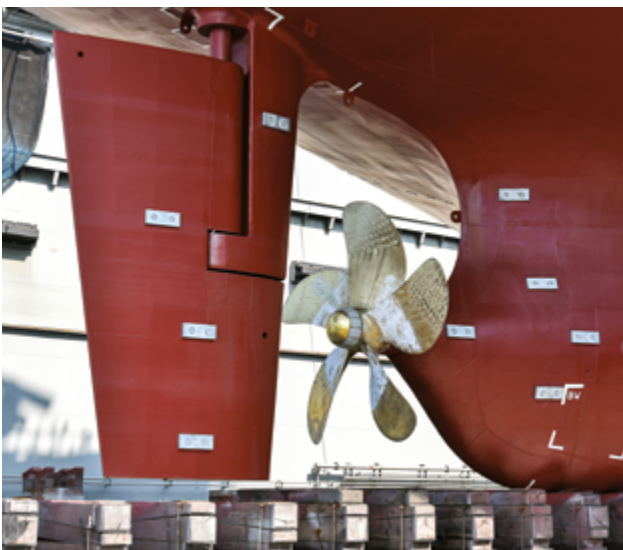
- the subject technical letter was never received in the company.
- there was no document to indicate that the potentiometer had been replaced since the ship's construction in 2007.

- there was no history of any previous malfunction of the system on the vessel nor on any other vessels in the fleet using the same system.

All vessels of the fleet equipped with the same system were directed to replace the potentiometer(s) as soon as practicable and their PMS updated to schedule potentiometer replacement every 5 years. All vessels equipped with the same steering control system were directed to post warning notices describing the steps to be followed in the event of a Servo Loop and FB Fail alarm. The company also contacted equipment manufacturers to investigate how their technical letters are circulated, to ensure proper communication in the future.

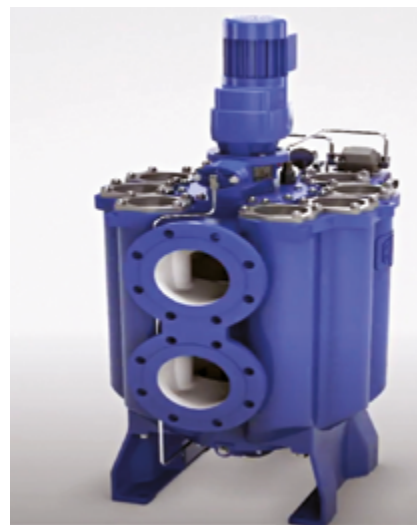
The vessel was alongside the berth. At 15.50 engineers started the removing the cover of the main engine fuel oil filter. Hot fuel sprayed onto the body and face of one of the engineers who was transferred to the ship's hospital for immediate medical attention, while urgent transportation to hospital ashore was arranged. The engineer was hospitalized locally for a week and then repatriated. According to the final medical report issued two weeks later, the engineer was recovering well but his condition would need to be re-evaluated in a month's time.
