## Communication: the key to better safety

# CHIRP

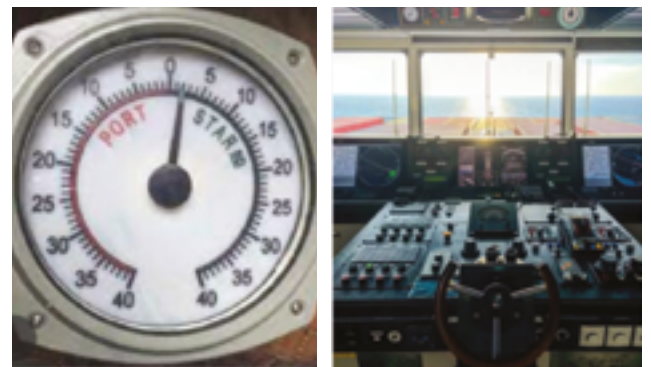
The helm correctly repeated back the 170° course to the pilot, who then looked down at their portable pilot unit (PPU). When they looked up, they saw that the ship had started to swing to port. The master and OOW challenged the error just as the pilot realised what was happening, and the swing was quickly stopped.

One possibility considered by the pilot was that the helm might have had the next (160°) course in mind, which was to port. Visually too, there was a shoal beacon fine on the starboard bow, and the helm might have intuitively turned to open the distance from that navigational hazard. The pilot put the incident down to being a human factor slip, which he felt reinforced the need to check the rudder indicator with all course changes.

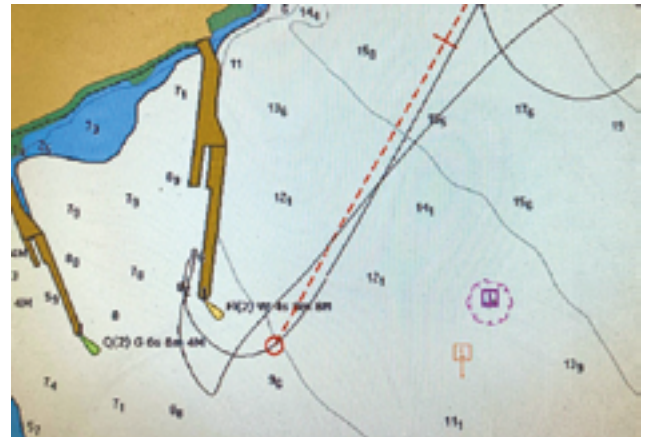
The main hazards were the proximity of the lee shore, with easterly winds, something that is factored into the passage plan to allow extra room, including the shoaling waters to the south of the berth; this knowledge allowed me to decide on early, positive and bold avoidance measures quickly, rather than allowing the risk to increase by proceeding onwards, even at a reduced speed, and allowing an unnecessary close quarters situation to develop.

As my vessel is on a timetabled service, we arrive and leave at the same time every day, weather permitting. Despite this, the cruise ship was allowed a departure that directly clashed with our arrival. A clash in movements such as this could have been avoided with a simple telephone call or email. After that, we could have timed our arrival later, thus preventing the situation above entirely.
