Single Points of Failure

Welcome to the Spring edition of FEEDBACK, our free safety newsletter for the global maritime community. We're delighted to report that we're now publishing in Arabic as well as the other seven existing languages, all of which can be found on our website or via our mobile app, which you can download using the QR codes printed on the back page of this newsletter.

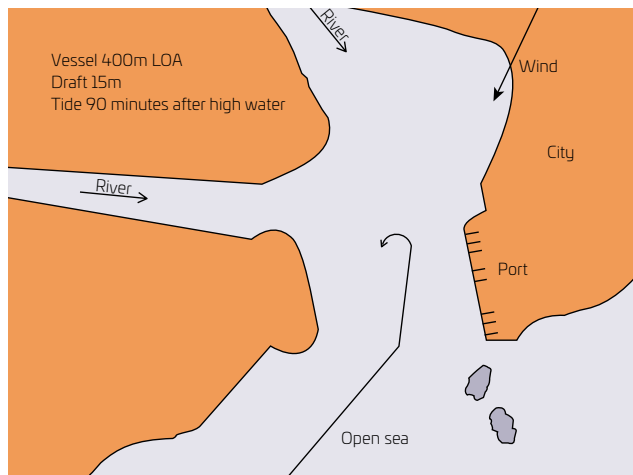
M2100

Vessel grounding in harbour

The pilot boarded a very large container ship at 0200 before it navigated into harbour. The wind was NNE 10 knots, the tidal current was to the SE, and visibility was good. The pilot noted after the incident that language difficulties reduced the effectiveness of spoken communication.

The briefing between the pilot and crew was hampered by language difficulties. The pilot became the 'single point of failure' as a result. A sketch or other visual aid would have helped develop a common understanding, making it easier to identify when the pilot needed assistance and to prompt constructively or question, e.g. "Are you aware that we are drifting towards the shallow patch?" This did not happen. As the vessel moved close to the jetty and other objects, the pilot's workload focus increased, and they lost overall situational awareness.

CHIRP strongly encourages teams to adopt the PACE (**P**robe, **A**lert, **C**hallenge, and **E**mergency) described in some depth in the CHIRP publication 'Making critical decisions at Sea', which is available on our website. Good communication and attention are essential, particularly at night when our circadian rhythms are often at their lowest.

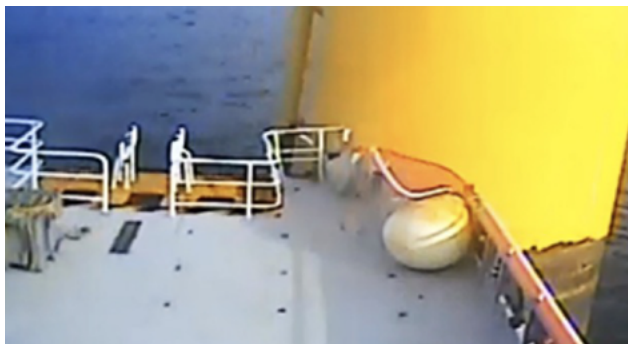
Workload distractions lead to a high-speed collision

As a Crew Transfer Vessel (CTV) was returning to port at high speed, the master became distracted by a lengthy radio conversation and did not notice that the vessel had been pushed off course by the tide. It collided with a wind turbine tower at speed, causing significant damage to the vessel. The weather and visibility were good. As is common for vessels of this length, only the master was on the

bridge; nobody else was keeping a lookout during the radio exchange.

Consideration should be given to increasing the number of lookouts during high-speed transit operations. Utilise your crew to highlight perceived hazards in the wind farm zones and use all navigational aids to assess the risks, especially on the chart plotter (alarms for off-track limits/cross-track error and radar guard zones).
