ANNUAL DIGEST

CHIRP

Annual Digest of Reports and Insight Articles 2022

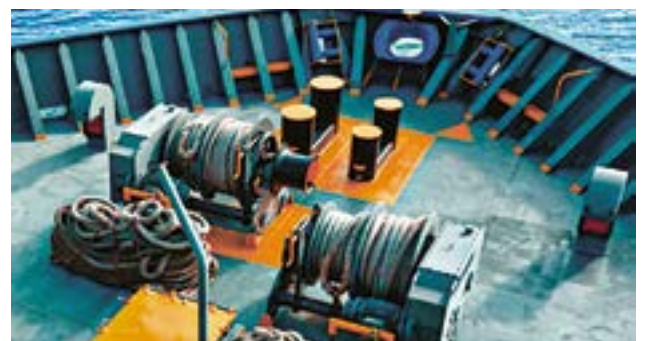
An ordinary seaman (OS) eased the tug's mooring rope out through the closed chock (Panama lead) and had taken a turn of the messenger rope around the bits. As the tanker turned to starboard to align itself with the berth the tug's line was in the water and as the separation between the tanker's bow and the tug increased, the messenger line paid out at an increased speed which was not anticipated by the line handlers.

The officer in charge of the mooring operation warned the OS to step clear from the messenger rope. The OS attempted to do so but slipped on the deck and became entangled with the rope which dragged him overboard through the Panama chock. The OS was recovered from the water by the tug and resuscitation and first aid was immediately administered until the ambulance took them to hospital. Tragically the OS died the next day.

This tragedy highlights the risks associated with all types of mooring operations.

Situational Awareness – Mooring operations can evolve rapidly and maintaining situational awareness during mooring operations is vital to ensure that everyone remains safe. Anticipation is key: lines can unexpectedly become taut or even break, creating a lethal snap-back hazard; winch brakes can fail or ropes be pulled overboard due to the relative motion of the vessel and the tug or bollard ashore.

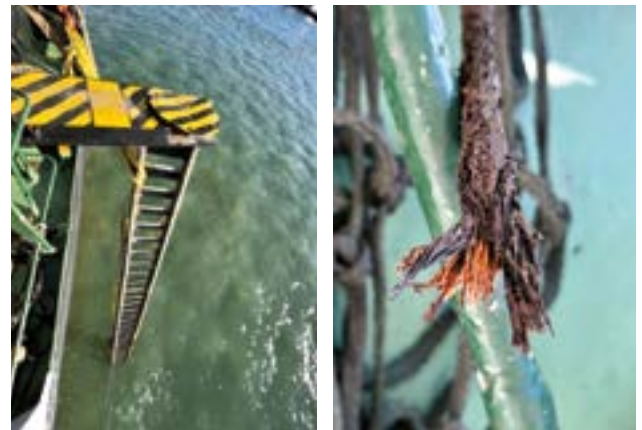
SOLAS regulation II-1/3-9 states that all wires used to support the means of embarkation and disembarkation shall be maintained as specified in SOLAS regulation III/20.4 which states that falls should be 'renewed when necessary due to the deterioration of the falls or at intervals of not more than 5 years, whichever is the earlier'.

Reducing the periodicity for changing the falls to between 18 and 30 months for vessels that have accommodation ladders in these exposed areas should be considered, as should changes to the design for securing the falls. However, thorough maintenance must always be provided to the wires, sheaves and fixtures no matter how difficult the access to the wires may be.

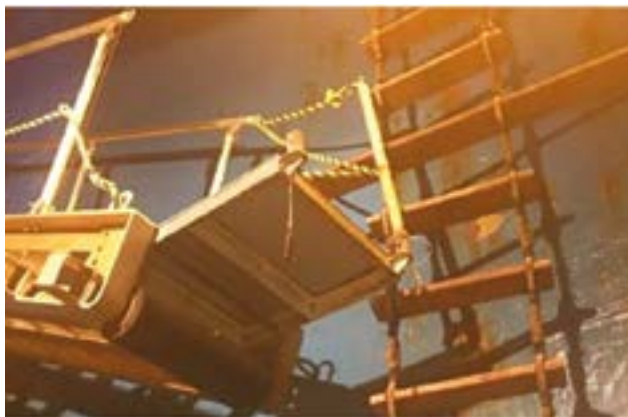
Combination ladders: Trapdoor Type Combination

The pilot who reported this incident had reported the same non-compliant transfer arrangements on this vessel two months earlier. At that time, the master was advised and given drawings of the required modifications. The port state was also informed. On arrival at the port two months later,

nothing had been done to rectify the situation.

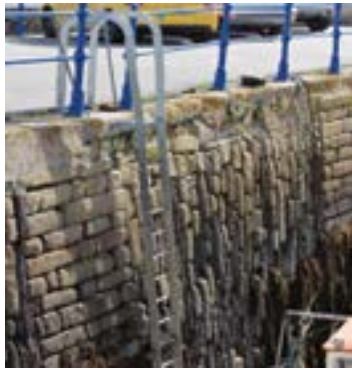
A fisher returned to their vessel with a guest in the late evening after they had met ashore. Both had drunk alcohol. It was low tide, and the vessel was approximately 6m below the quay edge due to the tidal range in that port.

As they climbed down the vertical quayside ladder, the guest fell off the ladder and hit the vessel's hull before falling, injured, into the water. The sea temperature was approximately 10° C (50° F).

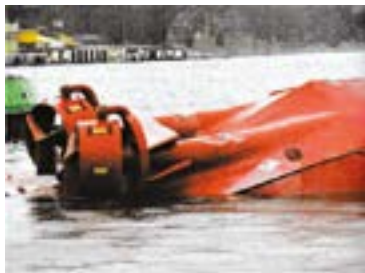
A tug had been engaged to assist a RO-RO passenger ferry in berthing in high winds. The ferry's master held a pilotage exemption certificate for the port, so no pilot was embarked. The tug was manoeuvring close to the port bow of the

ferry and attempting to connect a tow line when its stern collided with the ferry's bulbous bow, where it became pinioned, heeled to port and took on water. This caused the tug to capsize, resulting in the loss of 2 crew.

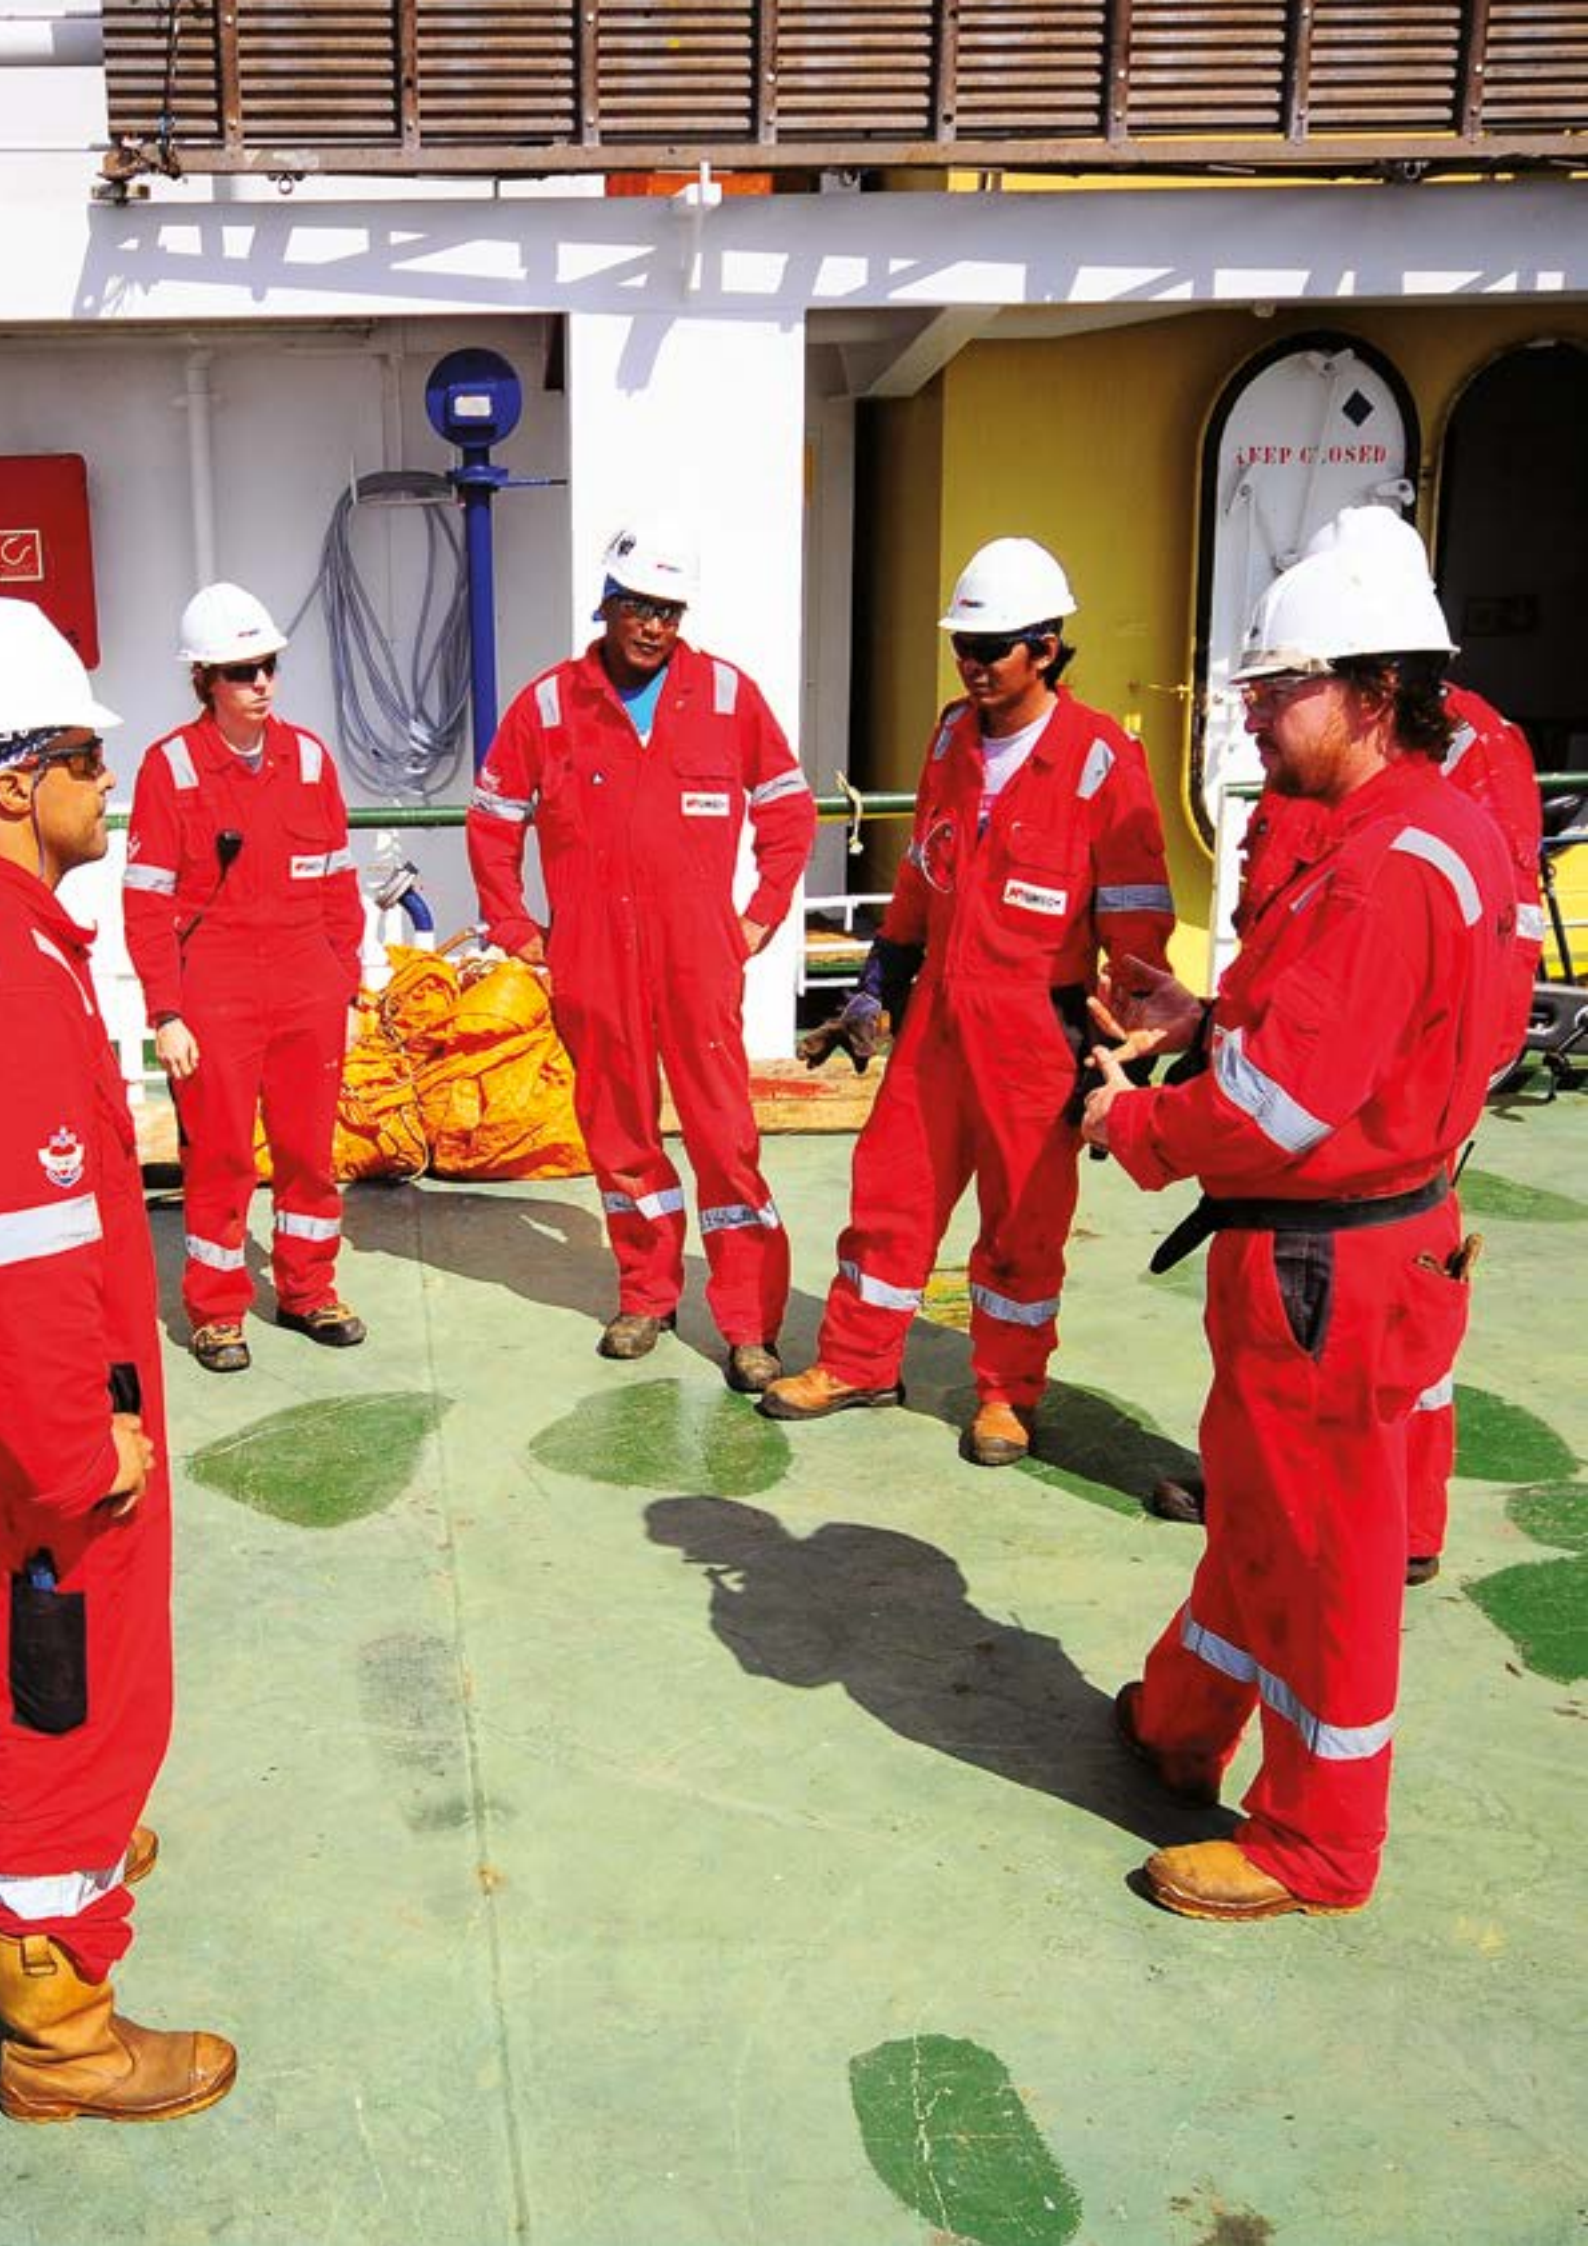
M1787

Poor safety standards on floating armoury vessel

A security guard working aboard a 50-year-old and 50m LOA floating armoury vessel reported unsanitary and unsafe conditions on board. These vessels provide privately contracted armed security personnel to commercial ships for armed protection while they transit areas of high risk.

Despite having a maximum capacity of 60 people, the floating armoury reportedly carries up to 150, and many are forced to sleep on the upper deck even in rough weather, due to the lack of available bunks. The water in the showers is rusty, there are cockroaches in the food, the electrical wiring is in a poor state of repair and water drips from the cable connections, creating a dangerous fire risk. The lack of an isolation area for Covid cases caused the virus to spread rapidly on board.

Because of this, garbage is thrown into the sea, contravening Marpol regulations. The hull was recently punctured, and repaired using quick-drying cement, but is unlikely to be properly repaired for many months until the vessel next visits port.

CHIRP raised these concerns with the Master and owners of the floating armoury vessel, who initially said that they wanted to improve conditions on board. However, no significant changes occurred so CHIRP passed the report to the vessel's registered flag state and its classification society, both of whom withdrew registration. This means that the vessel can no longer legally operate at sea until these issues are resolved.

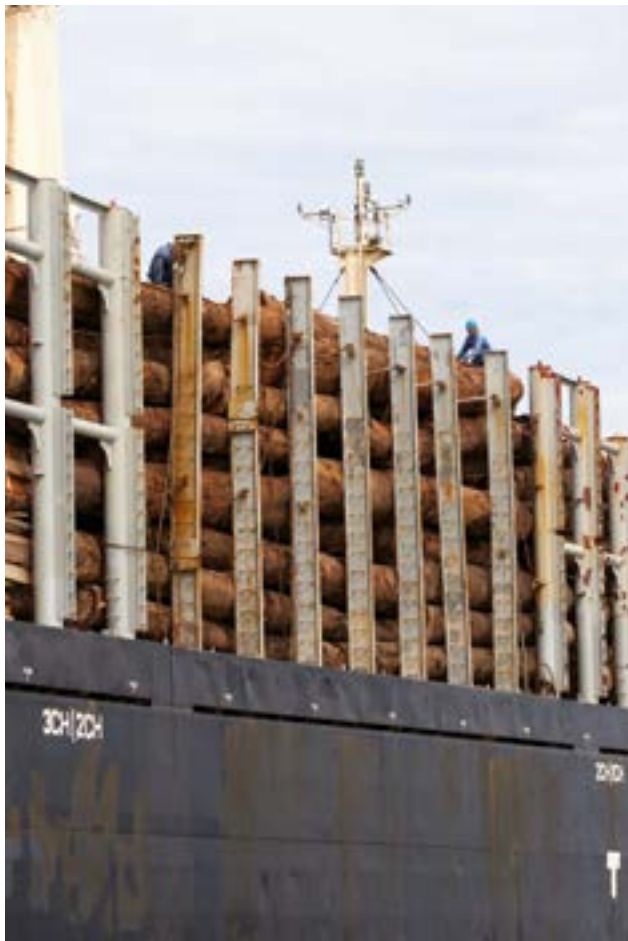
A bulk carrier was loading a timber deck cargo at anchor. While lashing down the timber, an Ordinary Seaman (OS) fell overboard into the sea. Another crew member jumped in to search for them but was unsuccessful, and despite an extensive search over several days, the victim was never found. What caused the OS to fall into the water could not be determined as there were no witnesses. The OS was inexperienced yet had not been trained or briefed on the risks of working on timber. He wore coveralls, gloves, a safety helmet, and studded overshoes. Still, the ship's SMS manual did not mention the rigging of safety lines or wearing safety harnesses when working on top of the timber, nor did it require the crew to wear lifejackets or buoyancy aids.

This report raises several organisational safety concerns. There was nothing in the company SMS about working at height on logs, nor any guidance on the rigging of safety lines or the wearing of safety harnesses. It would be impractical to rig a lifeline over the timber because it would interfere with the timber being loaded or unloaded by crane, but alternatives should have been considered. On board, the operational leadership knew of his inexperience, but did not

Working on top of logs to carry out lashings is hazardous and requires experience and training to do the work safely. The average height of a completed stack of logs varies from 5 to 8 meters above the main deck; a fall either overboard or to the deck can be fatal.

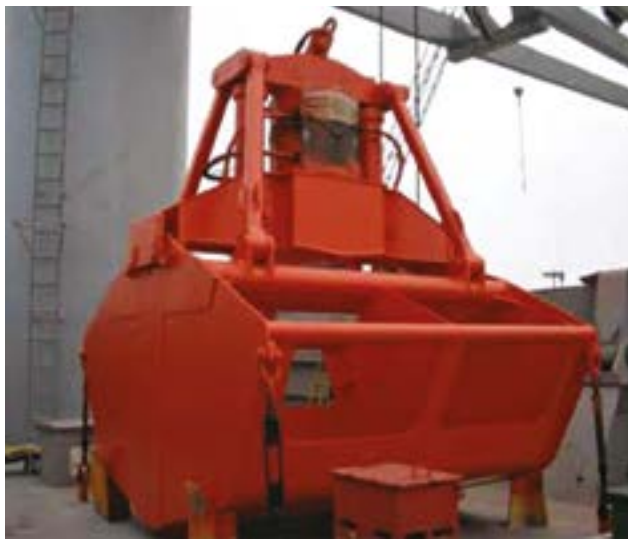
A three-person crew had been tasked to replace the wire rope of a cargo crane grab stowed on the main deck in its designated storage position. The weather was fair, and working at height precautions, including completing a Permit to Work, had been taken.

The grab's shape, size and position meant poor hand and footholds, although it was concluded that the crew member probably perceived the risk involved as acceptable and within his control. The fall prevention equipment on board was not ideal for vertical movements, so using equipment such as a double-legged energy-absorbing lanyard would have been more appropriate. The equipment was of a type that necessitated unclipping the safety harness lanyard to ascend or descend at the work site.

The ship's SMS procedures did not refer to hazards related to access/egress from a worksite at height, and it could not be determined if the risk of going up and down from the grab had been assessed.

The task was lengthy and required concentration throughout, which can bring about fatigue. When we finish a job, particularly one that is challenging or difficult, our brains release dopamine which causes positive feelings but can also impair decision-making, including when assessing risks. In combination, these factors would make the descent from this task perhaps the riskiest part of the job.

A fatigue management plan is useful in these circumstances: if a task can be broken into smaller parts, and either sufficient rest breaks or crew rotations are provided, then concentration and decision-making can be protected.

The company have suggested that a double-legged energy-absorbing harness would have been appropriate. CHIRP agrees, because a single-leg harness must be unclipped when climbing, descending, or navigating obstacles, thus removing the benefit of wearing a harness. And in this incident, a fall arrestor would not have worked because the crewman would hit the grab or the deck before it functioned.

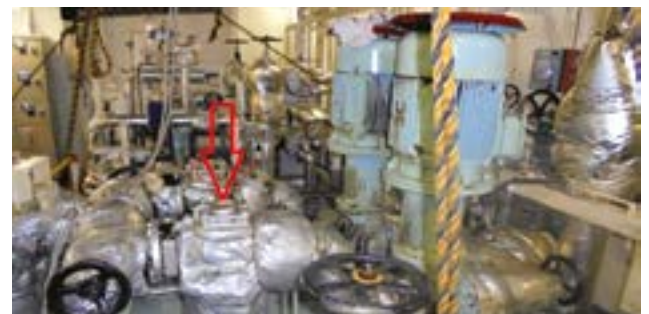
Personal Injury: Multiple crew burns in engine room

An engine crew suffered burns from the fuel oil pump of the auxiliary boiler

Risk Category/Severity: High (2 LWC Lost Workday Case, 1 RWC Restricted Workday case, 1 FAC First aid case)

The senior engineer, two wipers and one engine cadet assigned to the work suffered burns on their faces, skin, neck, and hands from the hot oil spray.

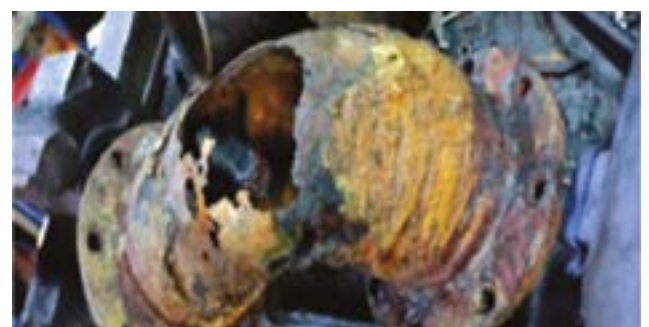
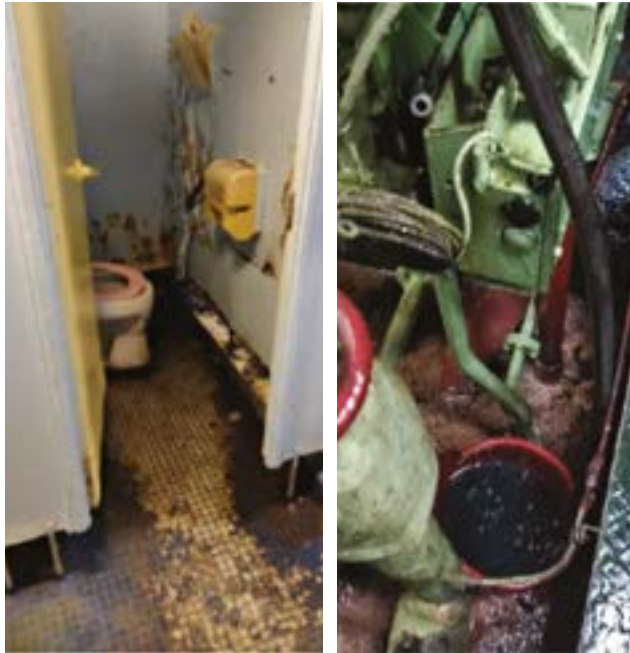
M2028 (submitted by ISWAN)

Enforcement of safety regulations – is it adequate?

A seafarer complained about awful working conditions on board their ship. The accommodation was unhygienic, food was insufficient, and the equipment was in disrepair: the main engine and gearbox leaked oil, and the seafarer claimed that oil and garbage were frequently discharged overboard. The air conditioning was also broken.
