Welcome to Drone FEEDBACK Edition 7. This is our first newsletter of 2023 and there are some very instructive Human Factors and Just Culture occurrences in this Edition. Amongst others, they include an Emergency Services Drone colliding with a Cessna 172 aircraft on final approach to an aerodrome, a 28kg Drone filming at the Henley Regatta that ran out of fuel (battery), dropped vertically and narrowly missed passengers sitting on a boat. The common link? Human Factors.

CONTENTS

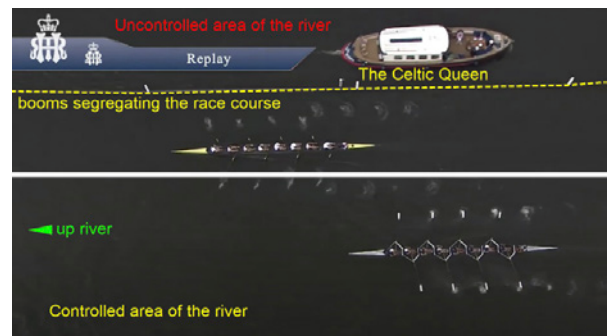
The UAS, a Freesky Systems Inc Alta X, was being operated commercially to provide video footage at the Henley Royal Regatta when a low voltage battery warning occurred in flight at a height of 50m. As the aircraft was being flown back to the landing site, the aircraft battery voltage reduced to the point where controlled flight was lost. It fell, in near free-fall, and impacted a boat on the river, causing damage. No persons were injured. The pilot could not recall checking the aircraft's battery voltage prior to take-off, and the low voltage battery warning had been changed to trigger at a lower level than that recommended by the manufacturer.

Image from the aircraft, with the Celtic Queen travelling down-river

The risk assessment performed by the operator had identified that a loss of battery power in flight could result in a 'catastrophic' outcome and was classified as an 'unacceptable risk'. However, the operator's classification reduced this to 'Low Risk' when mitigations were applied. These mitigations included checking the battery voltage level prior to take-off. However, the pilot could not recall performing this check.

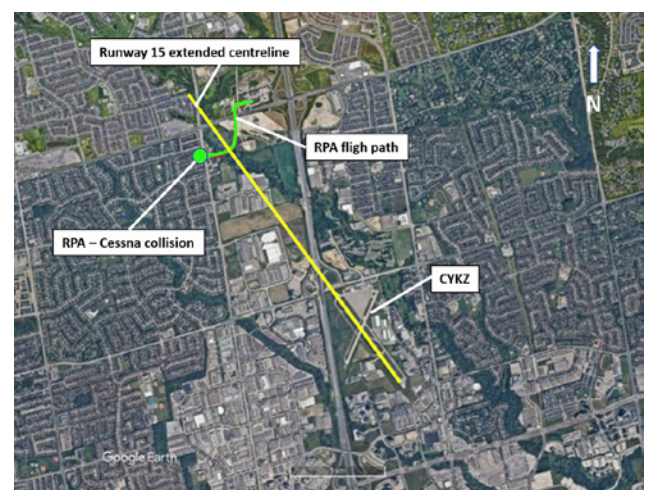
Overview of Toronto/Buttonville Municipal Airport and surrounding area showing the collision location, the Runway 15 centreline, and the RPA's flight path (Source: Google Earth, with TSB annotations)

CHIRP Comment: We think there are some good Human Factors lessons to take away from this report and are relieved that a more serious outcome did not result. This report shows how important it is to contact Air Traffic Control when you are flying in their FRZ, with precise details of where you will be flying. This applies even if there are operational reasons why time may be constrained. Although Emergency Services clearly have other considerations to consider as well, the safety of flight should not be made a secondary consideration to something they are doing even when the safety of life is just as much at stake. If the impact of the Drone had been a couple of inches higher it would have had an altogether different outcome we suspect.

Safety action taken: The York Regional Police has amended its Command Directive LE-388 to include the addition of a pre-flight risk assessment tool and an updated Remotely Piloted Aircraft Pilot Checklist. There is also additional guidance for the role of visual observer, including a quick reference card outlining their roles and responsibilities, as well as a requirement to have a visual observer present for all operational remotely piloted aircraft flights.
