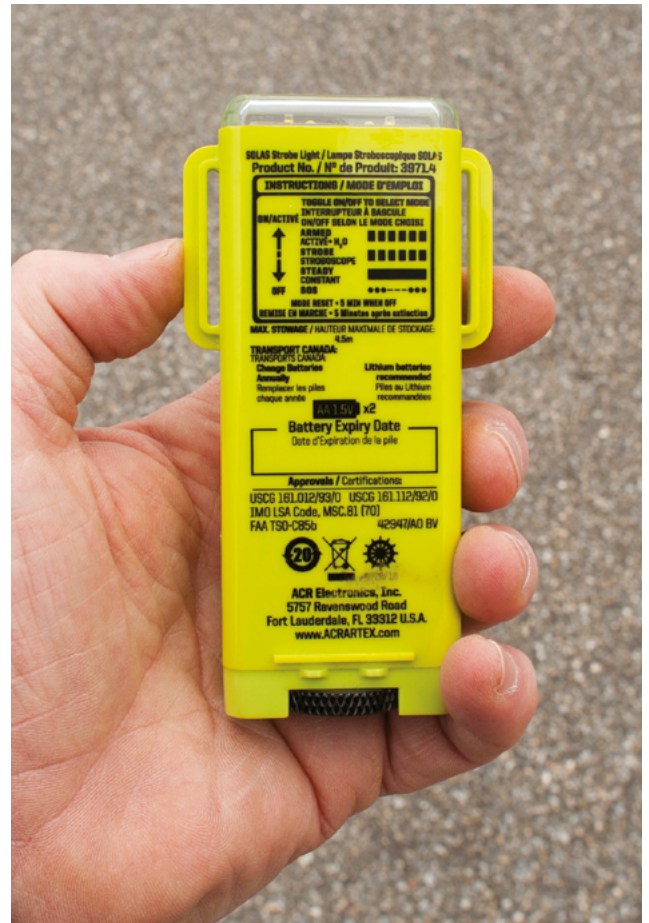
A typical personal locator beacon (PLB)

When fishing single-handed, CHIRP advises that a ladder is rigged to aid self-rescue or a floating messenger line attached to a lifebuoy streamed from the stern and next to the ladder. Fishers are also strongly encouraged to wear a waterproof hand-held VHF radio or (even better) a Personal Locator Beacon (PLB), which can alert the emergency services if you fall in.
