ANNUAL DIGEST

CHIRP

2023

Annual Digest of Reports and Insight Articles 2023-24

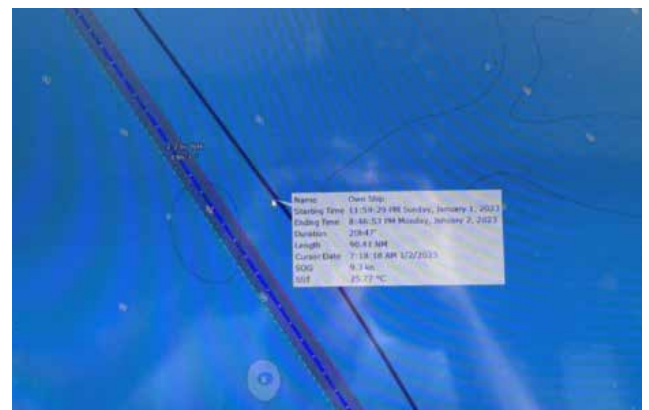
Screenshots of ECDIS (Electronic Chart Display and Information System) show that the planned track – shown as a dotted line – went over the top of a 1.9m shoal depth even though the vessel's draft was 2.3m. The vessel's course – shown as a solid line – was starboard of the planned track but still grounded because of a combination of shallow water, speed and squat. This resulted in the vessel dry-docking for several weeks for significant repairs.

The reporter explained that the master created all passage plans, but none were recorded in the vessel's navigation management system and that watchkeepers frequently had to deviate from the planned routes to avoid charted hazards. Our reporter was concerned that the master's proficiency in planning navigationally safe routes was lacking and that they sometimes struggled to interpret RADAR and ECDIS information. The reporter's employment was terminated when they raised these concerns through the company's safety reporting system.

Subsequent correspondence with the reporter revealed that to satisfy the owner or guests' requests to visit certain locations, the vessel often navigated to areas 'by eye,' i.e., visually detecting shallow areas because even large-scale charts lacked sufficient sounding data.

This report raises several issues. Firstly, although certificated, the master's navigational skills appear inadequate. It is vital that company managers validate the skill of masters and other senior officers and do not rely solely on the possession of a certificate as a measurement of competency. Secondly, route plans should always be cross-checked by another watchkeeper because even the best navigators can make mistakes.

CHIRP discussed with the relevant hydrographic office (HO) the issues experienced concerning navigating in the area related to the report. Crucially, a compliant ECDIS system must be used, and the charts must be updated to the latest edition and corrections. It was noted that an official ECDIS system with ENC was not used for the navigation of the vessel.

The HO placed great weight on using the sailing directions for the area as a pre-requisite before planning the passage. They contain valuable navigational information, including the nature of the seabed and the likelihood of shifting sandbanks, which in this case were prone to shifting. The vessel's speed must be set according to the under-keel clearance to avoid significant squat. Most fine-lined super yachts will trim by the stern when experiencing squat effect, and damage to the propellers and rudder can be expected if the vessel touches the seabed.

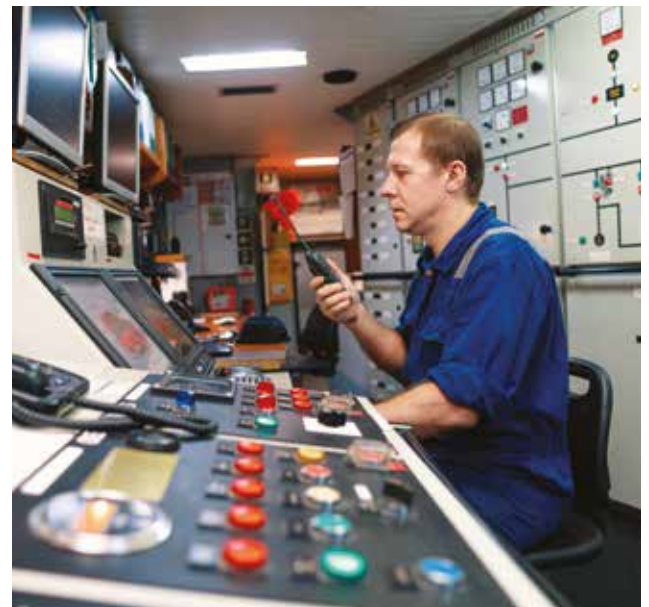
The 2nd engineer was in the engine room, next to the generators, helping the vibration specialist to gather readings from the gearbox. They noticed that a high-pressure fuel line to one of the generators had split and was spraying oil onto the hot exhaust manifold.

The 2nd engineer hit the generator’s emergency stop button, and the ship experienced a total electrical failure just as it was passing the breakwater. All navigational control was lost as a result, but luckily the emergency generator started, and power was quickly restored.

The chief engineer in the Engine Control Room should have requested permission from the bridge before changing the machinery state of the vessel so that the bridge team are always aware of the limitations of power and propulsion – especially when manoeuvring in or out of the harbour. Because the conversation would have also been broadcast over the loudspeakers in the engine room, those in the engine room would have been aware that only one generator was providing electrical power to the ship.

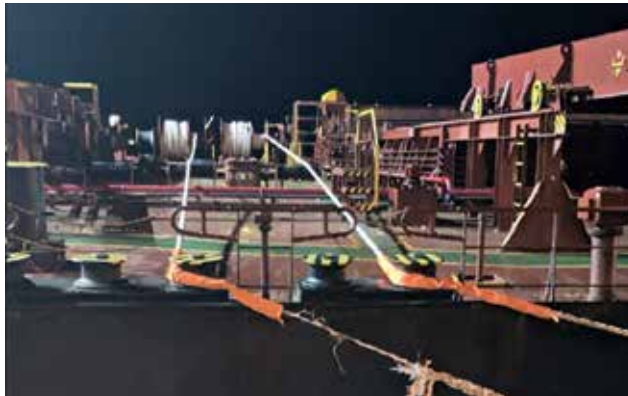
Properly installed moorings are not only essential for the safety of the crew but also for maintaining the ship's structural integrity. The risks associated with inadequately installed moorings—including the potential for fatalities, injuries, damage, and increased costs—can be effectively minimised by giving importance to mooring design and construction quality.

Vessel owners remain responsible for maintenance in most cases, and they should ensure that such hidden hazards are removed as soon as possible, or at the latest, during the vessel's next maintenance period.

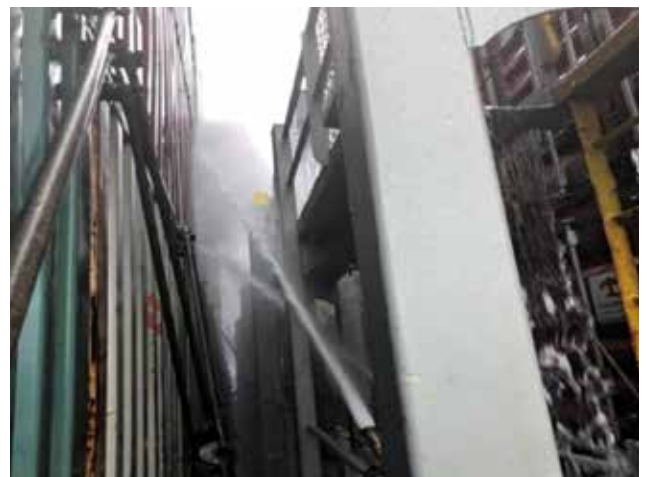
By following the CINS guidelines, stakeholders can significantly reduce the risk of incidents such as thermal runaway, which can be challenging to contain and extinguish. It is essential to mention that a thermal runaway event creates very high temperatures, toxic gases and can be inextinguishable.

Traditional fire-fighting techniques are inadequate for these fires, and there is an urgent need for both training and equipment to evolve to meet the hazards of an LIB fire. In particular, CHIRP is concerned that many ports have not established procedures for tackling such fires on board vessels, nor have yet designated a safe anchorage or berth for such an eventuality.

Shippers must strictly comply with all relevant national and international safety, health, and environmental regulations when transporting goods containing LIBs

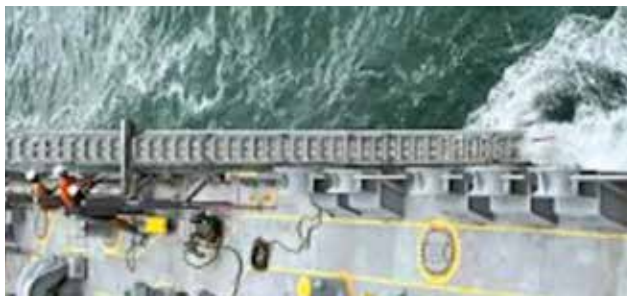
M2162

Severe Near Miss – accommodation ladder wire parts after pilot disembarks

The pilot reported that after disembarkation to the awaiting pilot launch, the accommodation ladder (part of a combination rig) was seen trailing in the sea when the wires for the accommodation ladder parted.

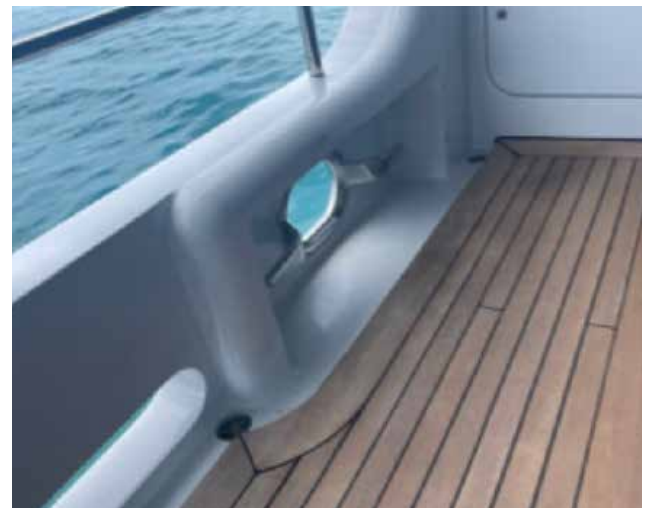
This is very much a seamanship matter concerning securing the tender and other vessels alongside, and the suggestion proposed is reasonable and seamanlike.

The company should consult the master on how the tender may be released in an emergency. CHIRP also suggests that preventing injuries to crew must be part of the design specification. The sleek-looking arrangement is in keeping with the aesthetics of the motor yacht, but it needs to be safe for the crew operating the moorings.

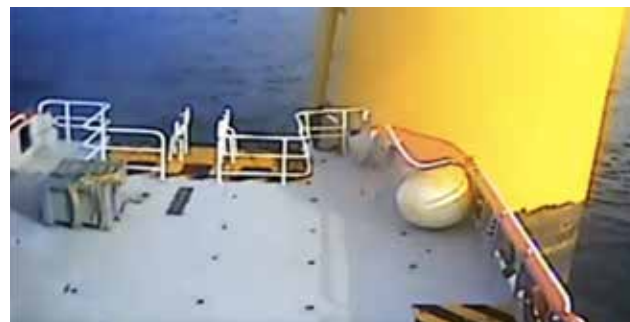
Workload distractions lead to a high-speed collision

As a Crew Transfer Vessel (CTV) was returning to port at high speed, the master became distracted by a lengthy radio conversation and did not notice that the vessel had been pushed off course by the tide. It collided with a wind turbine tower at speed, causing significant damage to the vessel. The weather and visibility were good. As is common for vessels of this length, only the master was on the bridge; nobody else was keeping a lookout during the radio exchange.
