Built to Break?

Design decisions shape safety outcomes at sea

M2494

Unacceptable design for pilot boarding and crew attendance

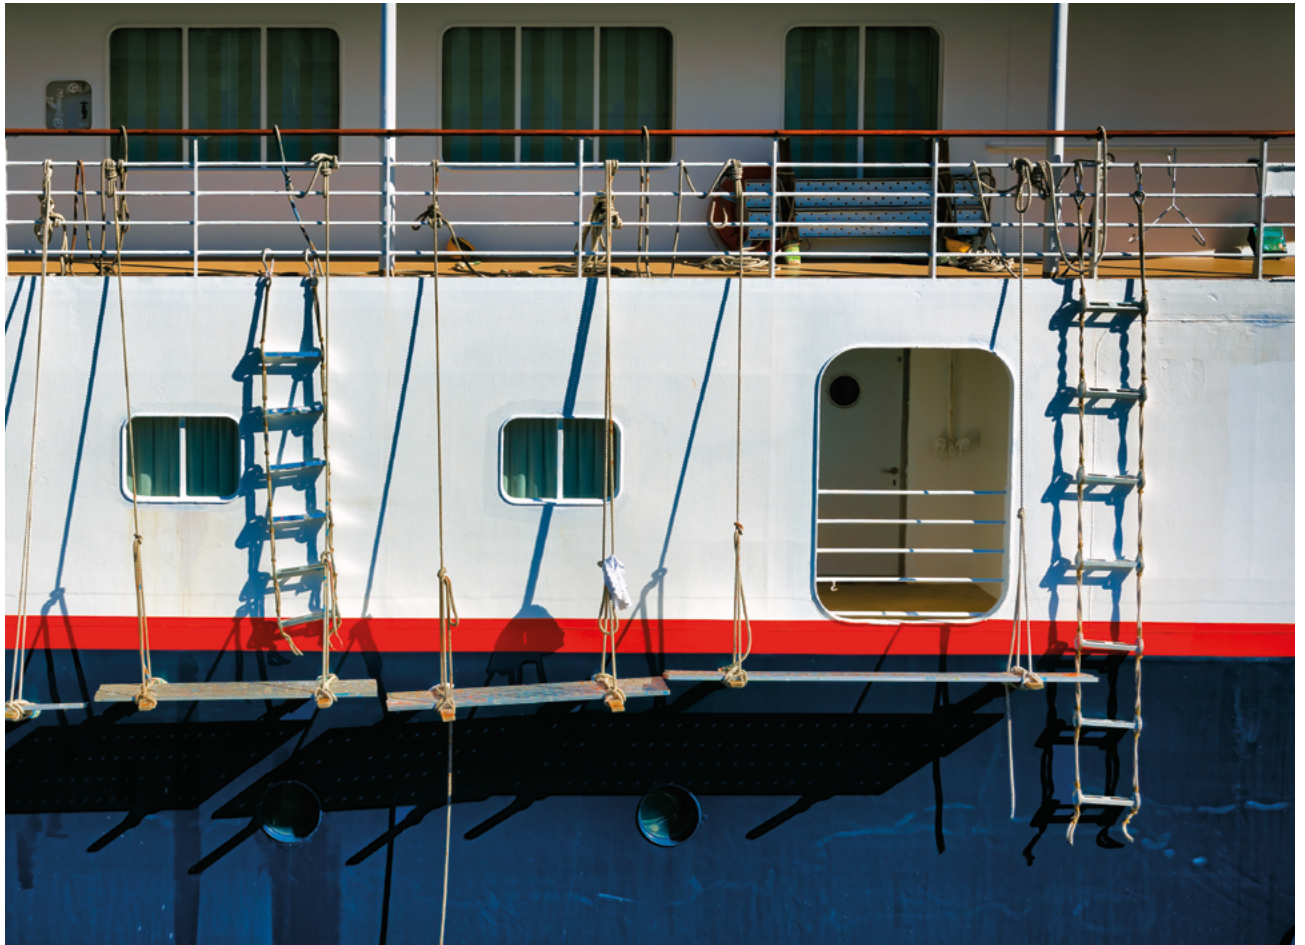
Representative image. Credit: Shutterstock

If the lower deck is the only viable transfer point, this must be clearly stated in the vessel's pilot card and agreed in advance. It is not helpful to inform the pilot when they are on the bridge about the transfer arrangement. This raises the question: do ports have heavy weather boarding procedures in place, with weather and sea state limits established? Only those conditions that fall within the criteria should be allowed for pilot boarding to take place.
