CHIRP GA FEEDBACK

Issue No: 66 4/2015

EDITORIAL

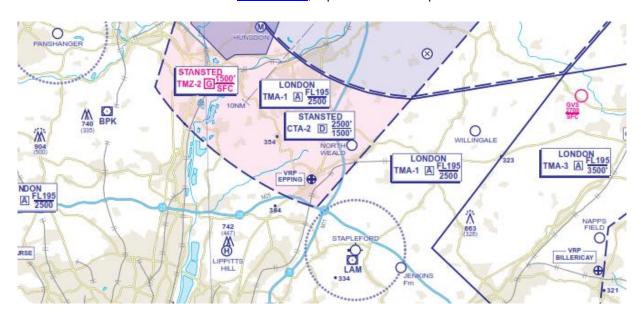
telephone call to ATC after landing is unlikely to exacerbate the situation; a timely apology can work wonders as well as eliciting immediate reassurance. For more information about North Weald, pilot briefing packs and TMZ briefing notes are available to download as pdfs from their <u>website</u>. There is also a very useful downloadable chart of the area on the AIS website; a portion of it is reproduced below.

Finally, the reporter was concerned that he may have infringed the Stansted CTR. A useful landmark is the water tower next to the M11 which marks the edge of the CTR. Following any suspected infringement, a
