### SUBMIT A REPORT

## What do you do after something goes wrong?

### GA – Always treat propellers as live

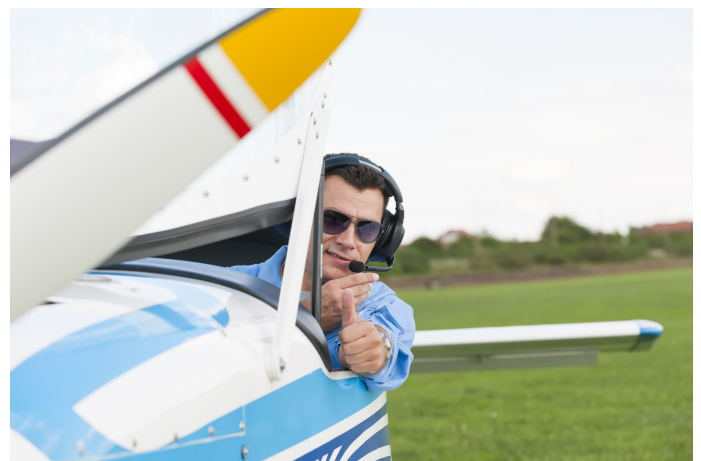
One day a while ago, I jumped into my airplane for a quick local flight and was shocked when I turned on the master and the prop started turning. I shut off the master right away. Fortunately, nothing – and more importantly no one – was

inside the prop arc. This happened because the starter contactor (which can also be called the starter relay) had failed in the 'on' position. Despite the fact that the airplane keys were still in my pocket, turning on the master powered the starter and the prop immediately started turning.

Because of this, I've added a 'Prop area – CLEAR' item **before** 'Master – ON' to my prestart check to ensure that if this happens again the possibilities of damage or injury are minimized.

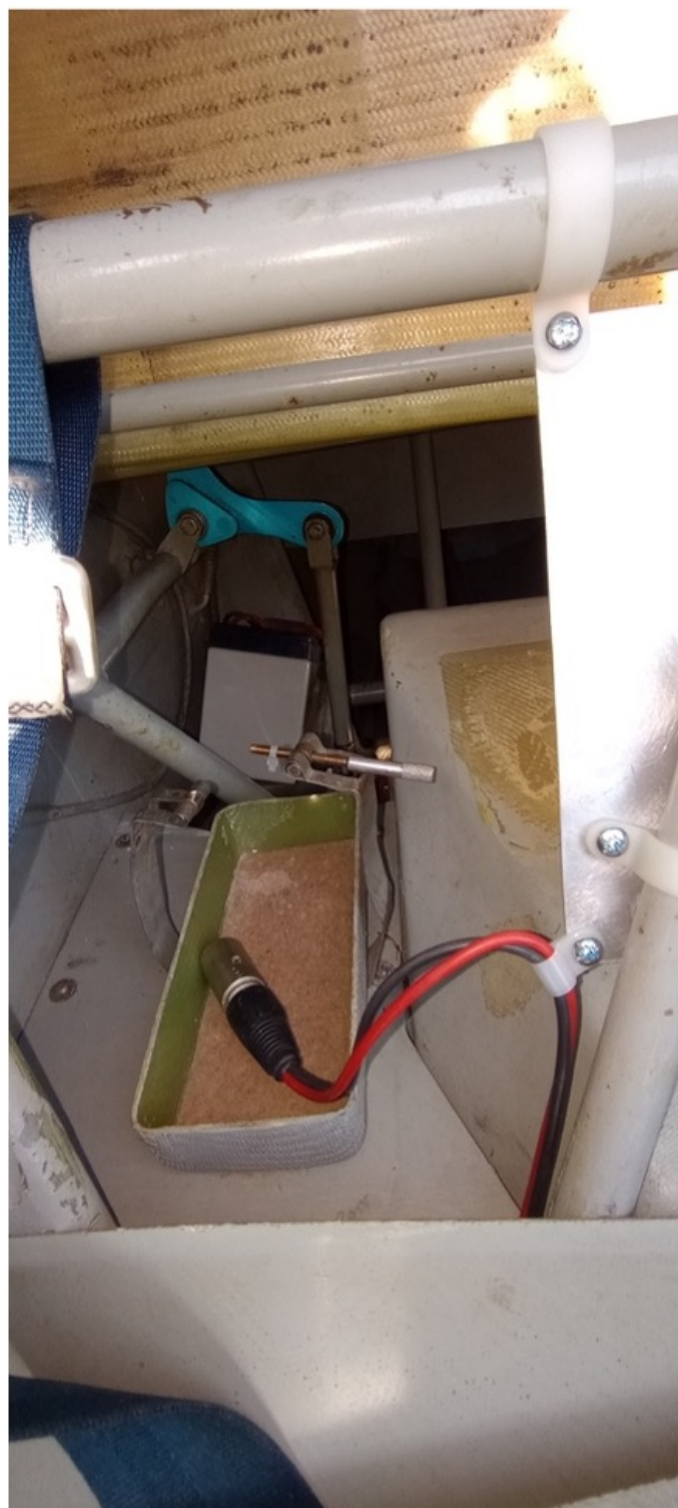
When we de-rigged at the end of the day, we found No1 battery had dislodged from its tray and slid backwards into

the area to the right of the U/C housing where the aileron-rod junction branches off into the starboard wing. When we had installed it to check the variometer we hadn't secured its safety latch and subsequently completely forgot about it. Although it was possible to move the control rod, the battery was lying on top and was being bounced around by any control column movement. Additionally, we noticed that the U/C rod extended back into this space, and the battery would have prohibited its movement if it happened to be settled in the rod's way.

Although it appeared that the battery did not completely obstruct the movement of the aileron control rod, it might be possible that such a situation could occur, either if it settled in a position which did not happen on the day, or if a slightly differently shaped – perhaps smaller – battery was installed.

I should perhaps add that my syndicate partner and I had never included an additional check of the battery position and latches in our DIs. They were simply always put in their slots, secured and the seat's back-rest put back in place and secured with its screw. Needless to mention that the installation of a battery is not mentioned in the aircraft operating manual in a glider of this vintage. Make sure to check that batteries are installed and secured correctly as part of DI, and always secure batteries, even when 'only' using them on the ground to check something.
