## GA FEEDBACK 100th edition

Some thoughts on 2023 and back to flying in 2024

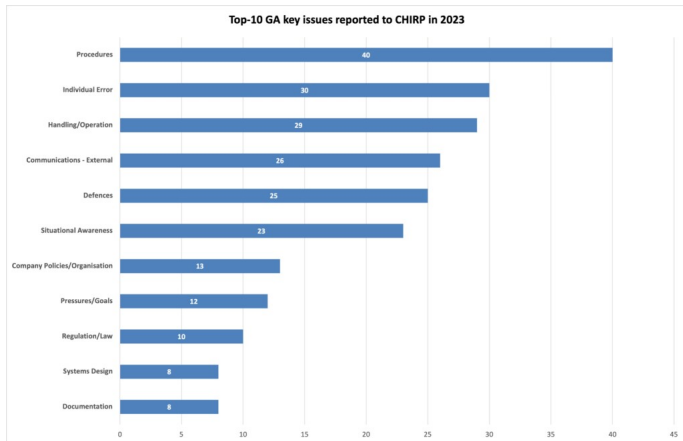
Coming back to the present, now that we've finalised the 2023 GA reports I thought it appropriate to see what themes and trends may have resulted. The bar chart shows the Top-10 GA headline issues, wherein it can be seen that **Procedures** and their application is the stand-out concern, with a fairly even split between, **Individual Error**, **Handling**, **Communication**, **Defences** and **Situational Awareness**. Note that a single report can have multiple key issues and so many of them are intertwined in the same incident.

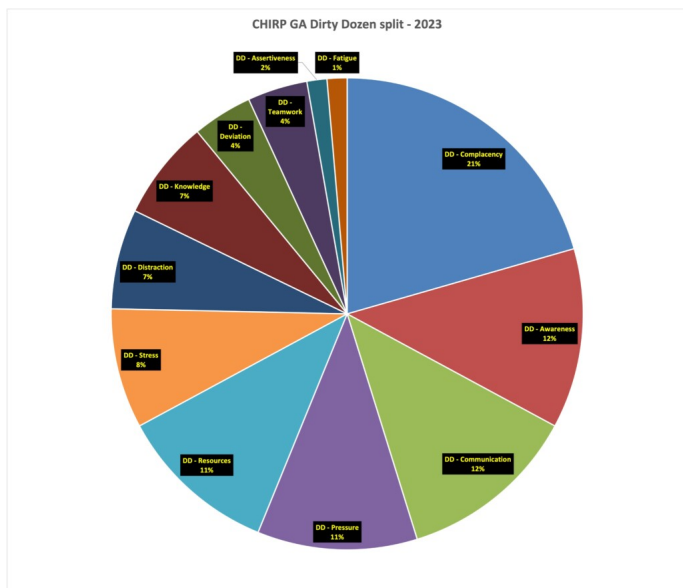
2023 saw us introduce the Dirty Dozen<sup>[1]</sup> Human Factors classification system as a way of providing some simple insights into the Human Factors reported to *CHIRP*. Although we're still evolving our process, the associated aggregated statistics for the year provide another way of looking at what has been reported to us as shown in the pie-chart. **Complacency**, **Awareness**, **Communication** and **Pressure** accounted for over 50% of what we've seen, although I emphasise that this is a fairly small sample size and there's more to be done to refine our processes in this respect.

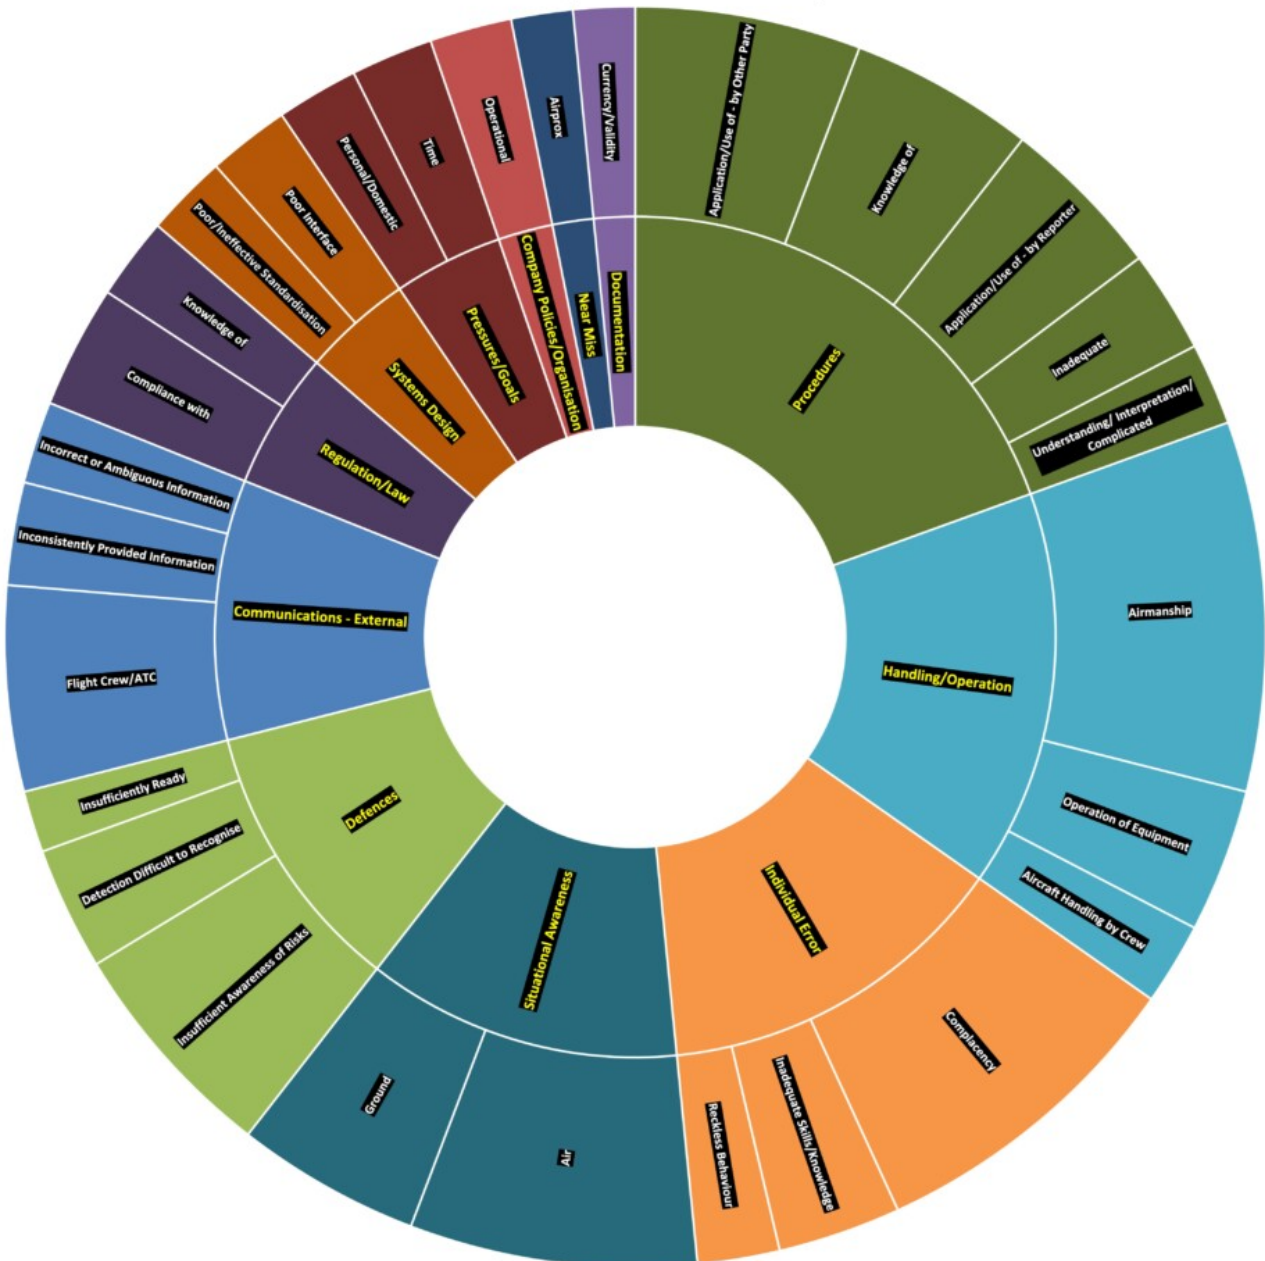
2023 - GA most common key issues and sub-issues reported to CHIRP

Perhaps more illuminating is the chart at the end which, although a bit of an eye-test, shows the associated sub-issues

within the key issues in the previous bar chart. Here it can be seen that the big blocks reveal a similar story to the Dirty Dozen in that **Airmanship**, **Complacency**, **Situational Awareness** (in the air), **Insufficient Awareness of Risks**, **Application of Procedures**, and **Communication** (between flight crew and ATC) were the main areas of concern. So, plenty of food for thought for all of us as within those themes as we prepare ourselves for the hopefully better weather ahead after the dismal first few months of 2024.
