MOORING INCIDENT ON AN LPG TANKER

Report Title Mooring incident on an LPG tanker

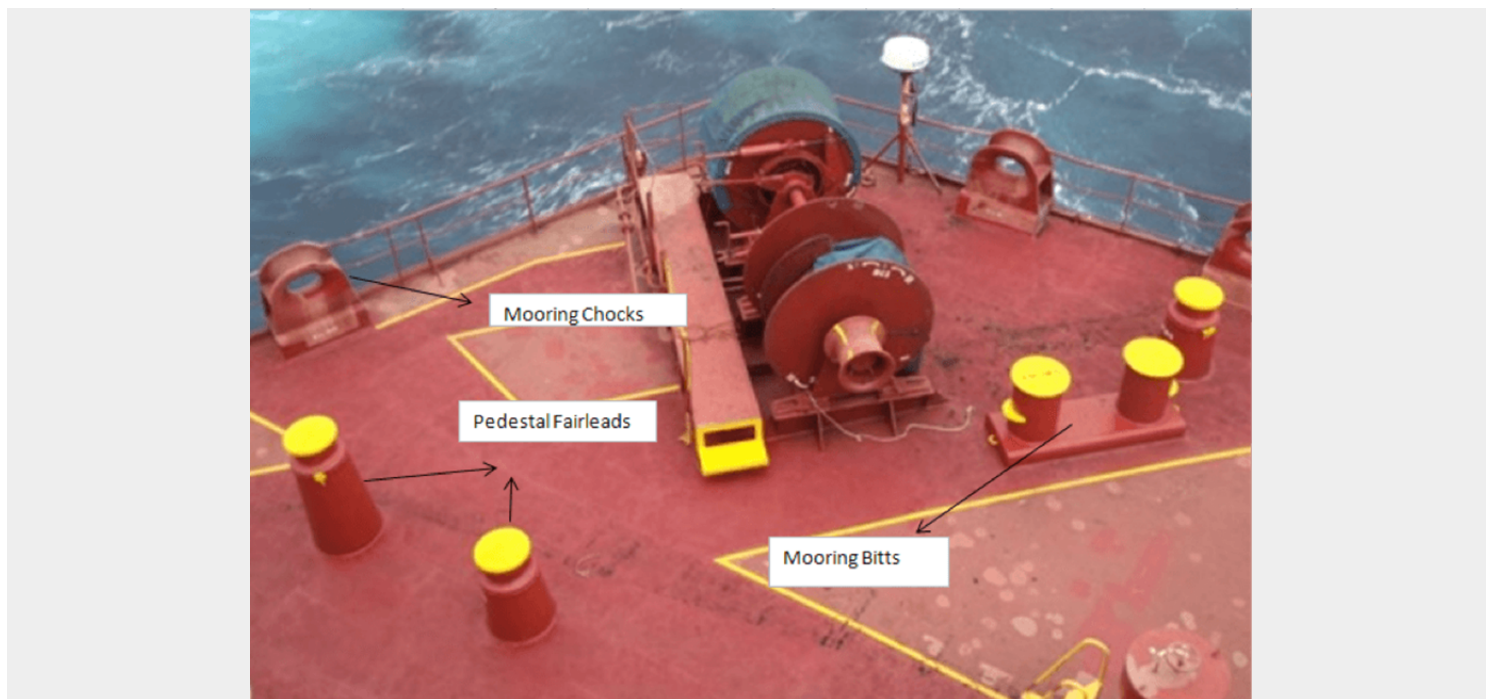
Example of a typical modern mooring arrangement (Not the vessel in the report)

- The berth in use was more exposed than others in the port.
- The vessel is fitted with soft line mooring ropes throughout whilst similar vessels are equipped with mooring wires.
- The vessel's length and fairlead positions are not ideally suited for the quayside bollards.
- The vessel is fitted with Panama fairleads throughout which are not best suited for soft lines.
- Mooring ropes on board are a mixture of split drum and loose ropes which turn up on the bitts.
