GA ILAHFFT - ALL SECURE?

Posted on 27.02.2024 by Steve Forward

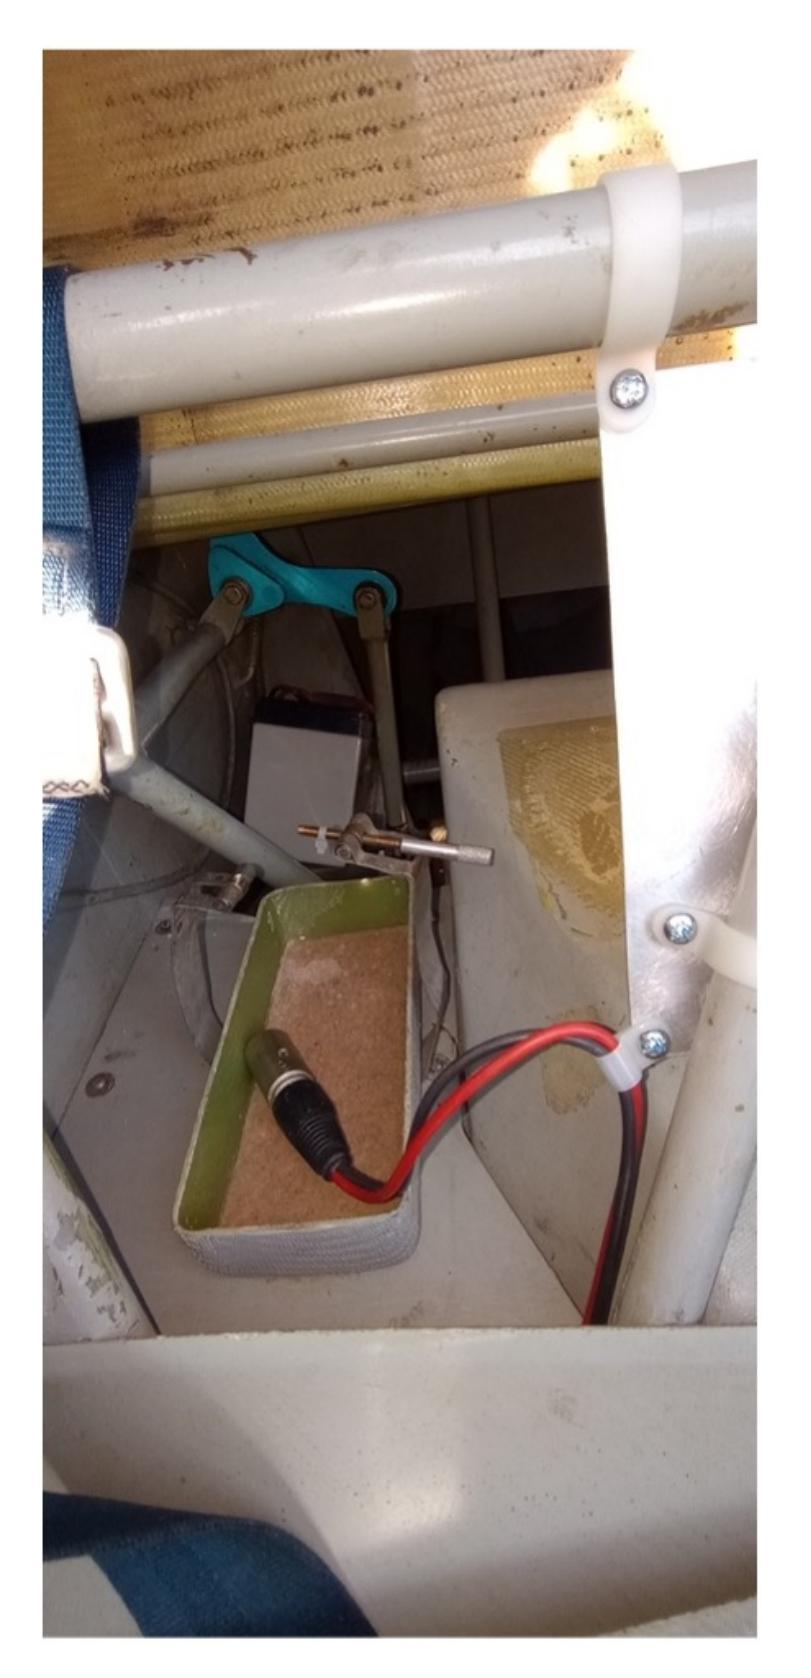
When we de-rigged at the end of the day, we found No1 battery had dislodged from its tray and slid backwards into the area to the right of the U/C housing where the aileron-rod junction branches off into the starboard wing. When we had installed it to check the variometer we hadn't secured its safety latch and subsequently completely forgot about it. Although it was possible to move the control rod, the battery was lying on top and was being bounced around by any control column movement. Additionally, we noticed that the U/C rod extended back into this space, and the battery would have prohibited its movement if it happened to be settled in the rod's way.

Although it appeared that the battery did not completely obstruct the movement of the aileron control rod, it might be possible that such a situation could occur, either if it settled in a position which did not happen on the day, or if a slightly differently shaped – perhaps smaller – battery was installed.

I should perhaps add that my syndicate partner and I had never included an additional check of the battery position and latches in our DIs. They were simply always put in their slots, secured and the seat's back-rest put back in place and secured with its screw. Needless to mention that the installation of a battery is not mentioned in the aircraft operating manual in a glider of this vintage.Make sure to check that batteries are installed and secured correctly as part of DI, and always secure batteries, even when 'only' using them on the ground to check something.
